Experimental Characterization of Compression Failure Mechanism Initiation and Growth in Notched Carbon Fiber Reinforced Composite Specimens

Abstract

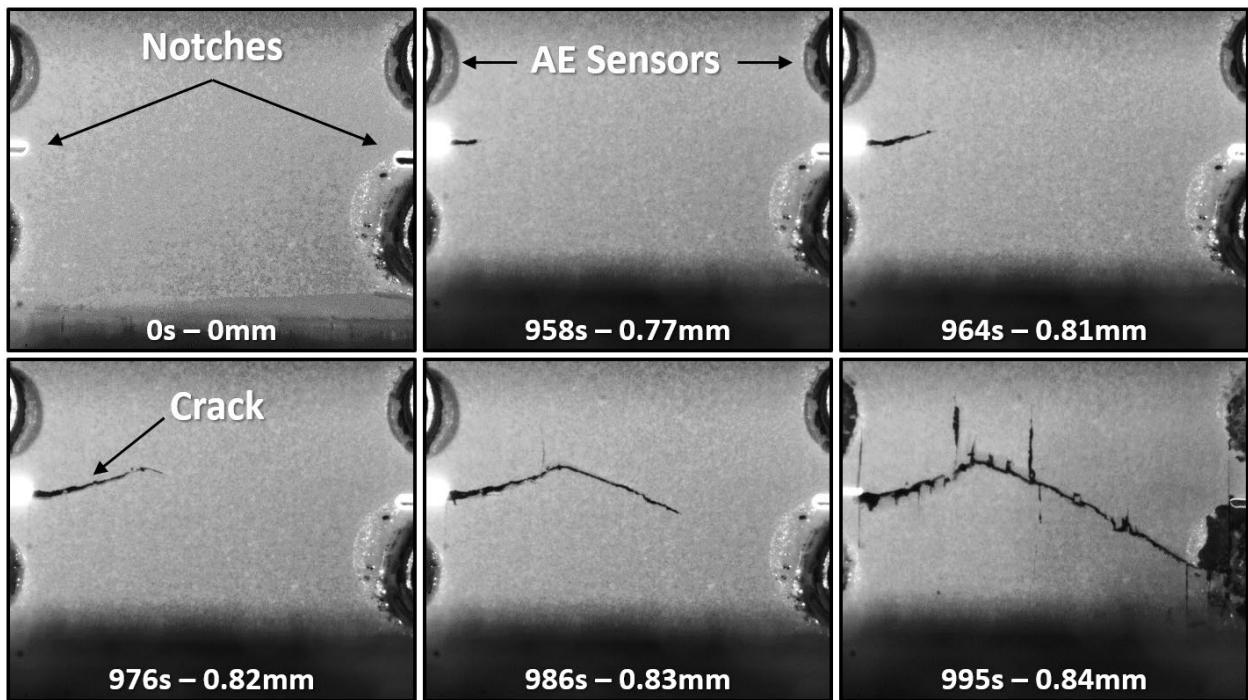
Figure 2. Optical images from the DENC screening test of progressive damage showing test time and crosshead displacement.

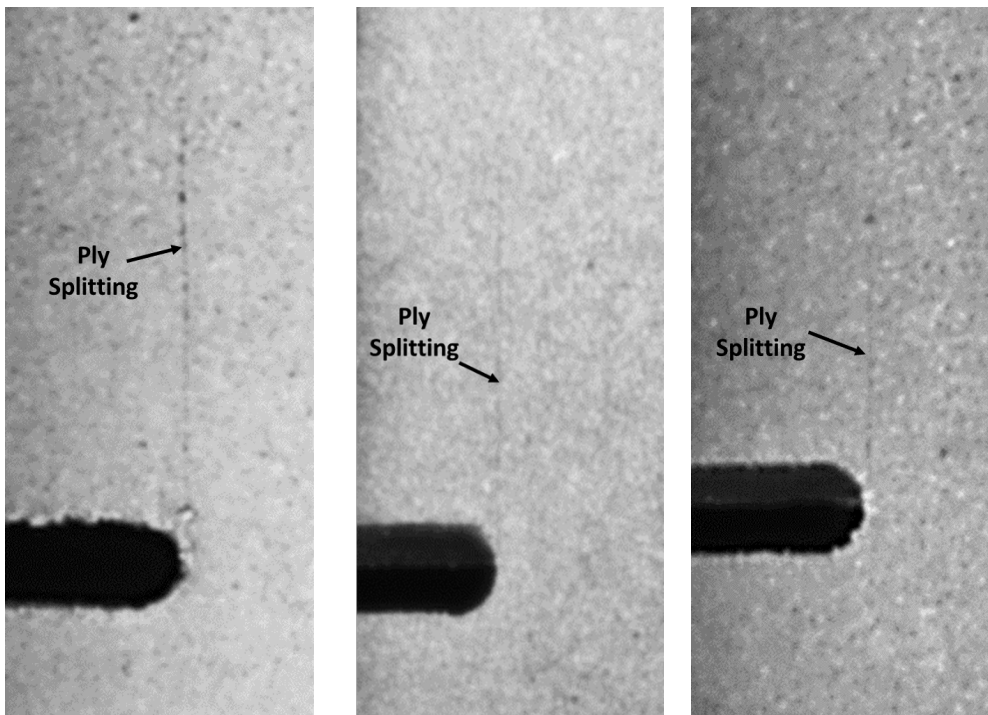
During testing, digital cameras were used to observe the specimen surfaces as previously described. Figure 8 displays representative optical images of surface ply splitting commonly seen on Level 1 test specimens.

Although surface ply splitting is challenging to capture real-time, it was observed on approximately 75% of the Level 1 specimens prior to stopping the tests for more detailed inspections. Splitting was initially observed in the nominal stress range of 150 to 175 MPa with an average length among 6 specimens of 1.66 mm (Coefficient of Variation, CV 35.5%). It can be seen that the split emanated from near the notch tip and extended toward the upper or lower edge of the test specimen. The images obtained for the Level 1 specimens do not clearly show whether or not the split extended through the thickness of the zero-degree plies.

Figure 8. Digital images of surface ply splitting initiating from the notch tip in Level 1 test specimens

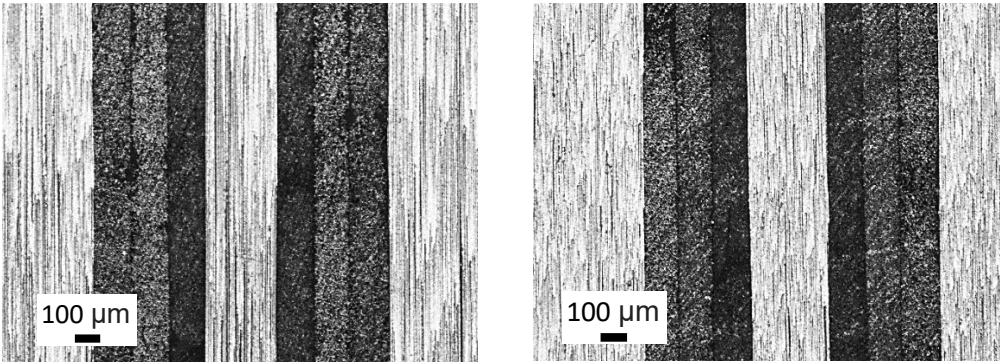
In order to further characterize the internal damage at these low stress levels, some of the test specimens were ground, polished, and micrographed according to the procedure described above. Figure 9 shows representative micrographs near the notch tips of two Level 1 test specimens. There was no indication of kink band formation or other type of damage up to stress levels of 210 MPa. Based on the combination of the surface images and the internal micrographs, it is concluded that the Level 1 acoustic events were not the result of kink band formation but were caused solely by surface ply splitting.

Figure 9. Micrographs of ground/polished Level 1 specimens.

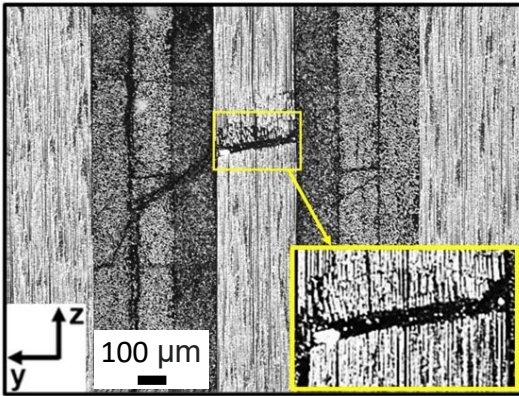
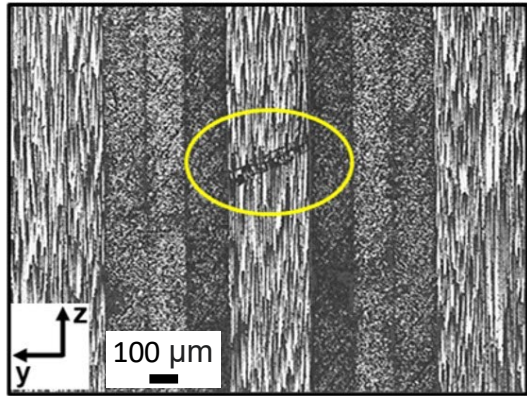
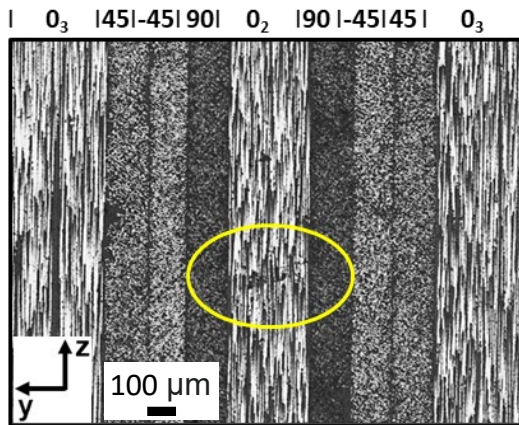
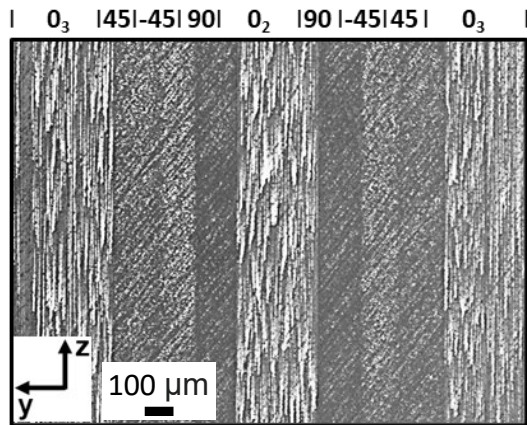
Figure 11 shows a schematic of the test specimen coordinate axes and four images of a Level 2 characterization specimen that was incrementally ground, polished, and micrographed after it was loaded to a nominal stress of 294 MPa. This same process was repeated on several other specimens at different stress levels in order to thoroughly characterize kink band growth as a function of compression stress. Figure 11(b-e) depict a cross-sectional view through the thickness of the specimen at increasing distances from one of the notch tips. Noticeable damage in the center zero-degree plies and adjacent forty-five degree plies can be seen in Figure 11b at a close distance of 0.15 mm from the notch tip. In this specimen, the outer zero-degree plies do not exhibit any damage. The remaining images focus on the region between 2 and 3 mm from the notch. At 2.2 mm (Figure 11c), a well-established kink band can be seen in the center zero-degree plies, but no other damage is evident. The center kink band is barely visible at a depth of 2.6 mm (Figure 11d) while no

damage is seen at a depth of 3.0 mm (Figure 11e). These results indicate that the length of the kink band is between 2.6 and 3.0 mm.

Figure 11. Micrographs of polished specimen at increasing distances (x) from the notch tip (a) specimen schematic, (b) 0.15 mm, (c) 2.2 mm, (d) 2.6 mm, and (e) 3.0 mm (color on web only)

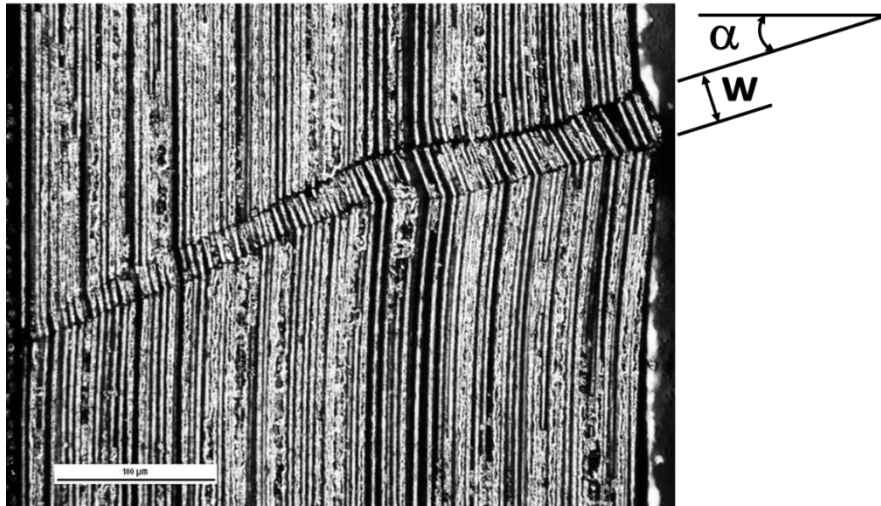
Thorough investigation of kink band formation and growth using this grind/polish/micrograph approach was conducted on six of the fifteen Level 2 characterization specimens. Figure 12 shows a sample image of a kink band in the center zero-degree plies of one of the Level 2 specimens with the angle (α) and width (w) annotated. Table 3 shows the results of the microscopic kink band characterization. Five of the six specimens were tested to at least 90% of the average ultimate stress (318 MPa) found during baseline testing. Similar to what was extracted from the images in Figure 11, the kink band length from the notch tip is given as a range rather than a single value since it was determined from a series of micrographs at discrete distances. The maximum possible kink band lengths were found to be in the range of 1.5 to 3 mm, which is approximately 10 to 25% of the distance between the two notches. Similar kink bands may have formed from the opposite notch, which would indicate that the progression across the width of the specimen could be as high as 50% of the gage section but is likely significantly less. The measured values of both the width and angle of the kink bands were found to be very consistent. The average width was measured to be 0.025 mm (CV 14.7%) while the average angle was found to be 23.2 degrees (CV 9.1%). In the previously published literature, kink band morphology has been measured in other notched carbon-fiber/epoxy laminates containing nonzero-degree plies. These examples include 17 $\mu\text{m/s}$ compression loading of multidirectional (various layups consisting of forty-five, zero, and ninety-degree plies) open hole T800/924C specimens additionally supported with an anti-buckling device [2], and 1 $\mu\text{m/s}$ compression loading of cross-ply single-edge notched IM7/8552 specimens [23]. The kink band length is observed at 20-30% of the unnotched width immediately prior to failure. Kink band widths and angles were observed in the ranges of 20-35 μm and 5-30 degrees, respectively.

Figure 12. Micrograph of kink band with annotation of characterization parameters (α = angle with respect to horizontal direction and w = kink band width)

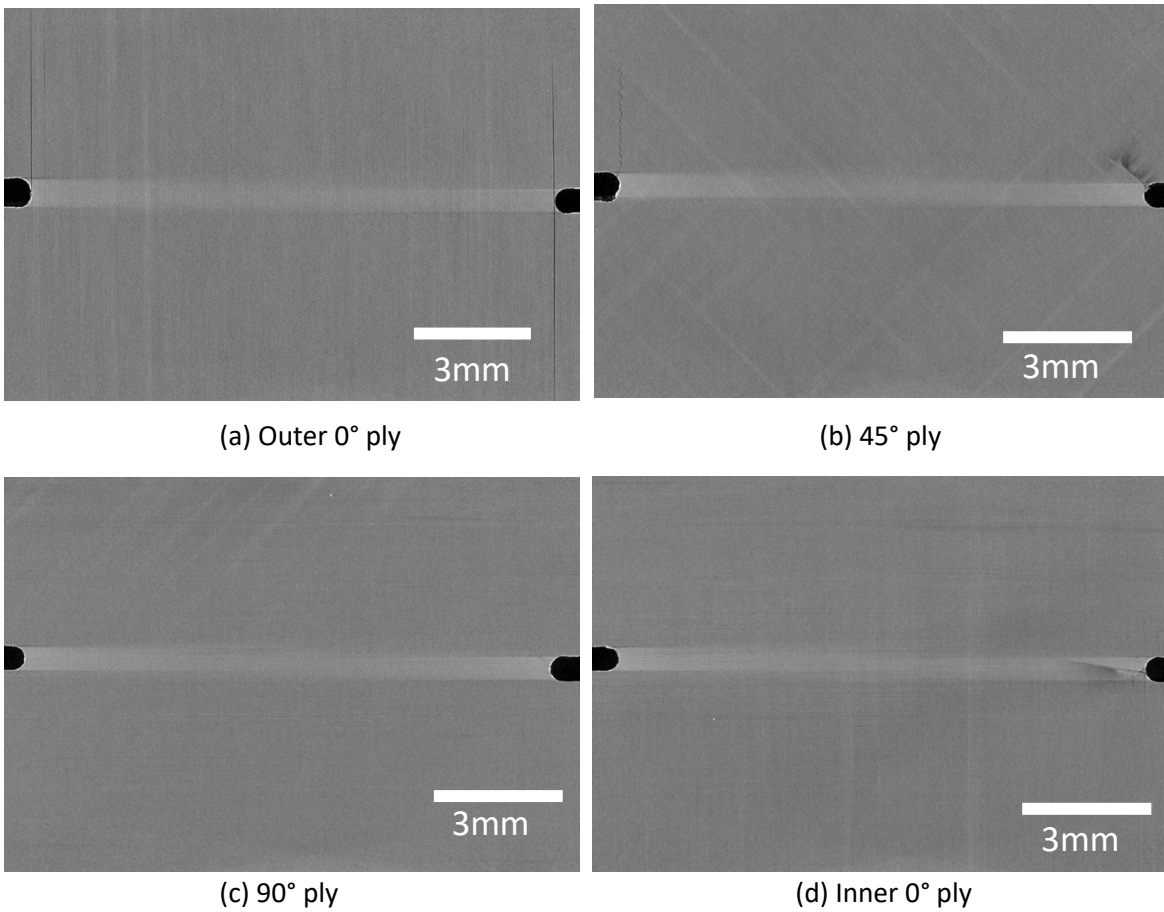
of the baseline specimens. Internal damage is shown in the low magnification ($0.395\ \mu\text{m}$ to $7.55\ \mu\text{m}$ voxel size) tomographs of Figure 13. It can be seen in Figure 13a that the outer zero-degree plies experienced ply splitting from both notch tips, which agrees with previous observations from optical imaging. No kink banding was evident on the outer plies and no splitting was observed at the notch in the inner zero-degree plies. Figure 13b shows that the forty-five degree plies were affected by the surface ply splits and experienced jagged and angled splitting/cracking at the notch tips. In the high magnification tomograph shown in Figure 14, it can be seen that kink bands formed within the jagged damage pattern in the forty-five-degree plies. Other experimental results using optical microscopy have shown kink bands propagating in exterior non-zero-degree plies in notched carbon-epoxy multidirectional laminates under compressive loading. In Sivashanker, 2001, [24] kink bands are visible in forty-five-degree plies in segments orthogonal to the fiber direction and are connected by much longer matrix cracks than visible in Figure 14. The result is what appears to be a jagged fracture path propagating transverse to the loading direction. No information is provided on splitting of the interior zero-degree plies. While a clear matrix crack is present close to the notch height in Figure 14, the damage does not propagate in the transverse direction from the end of that matrix crack. To our knowledge the jagged damage pattern observed in Figure 14 which aligns primarily with the splitting in the zero-degree plies has not been reported before and points to the effects of exterior zero-degree ply splitting on the DENC failure process. The split at the left notch in Figure 13a is longer than the jagged kink band damage in Figure 13b, which could indicate that the exterior ply splits caused stress redistribution and consequently this damage pattern in the forty-five-degree plies. No internal damage was detected in the ninety-degree ply shown in Figure 13c. Figure 13d shows a kink band protruding from the right notch tip. A more detailed description of the kink bands is given in Figures 15-16.

Figure 13. μ CT images of four plies of damaged DENC specimen. Voxel size is 7.55 μ m.

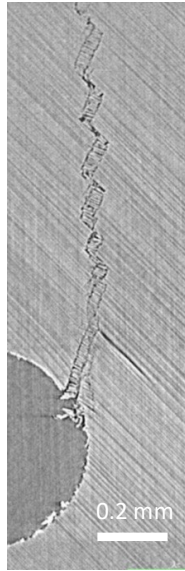
Figure 14. High magnification μ CT tomograph of split/kink band in 45-degree ply (see Figure 13b).
Voxel size is 2.55 μ m.

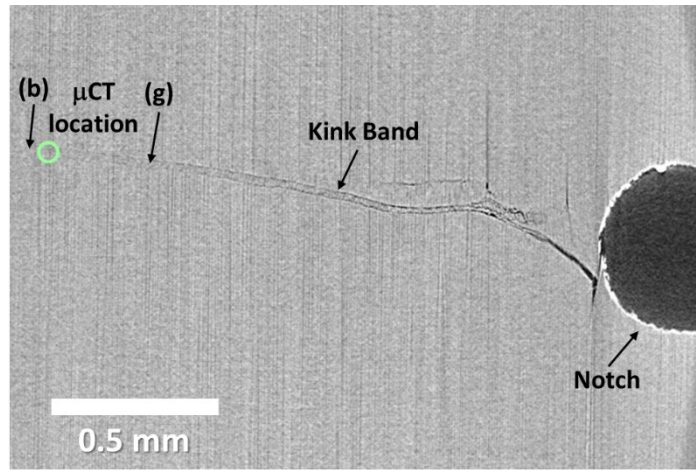
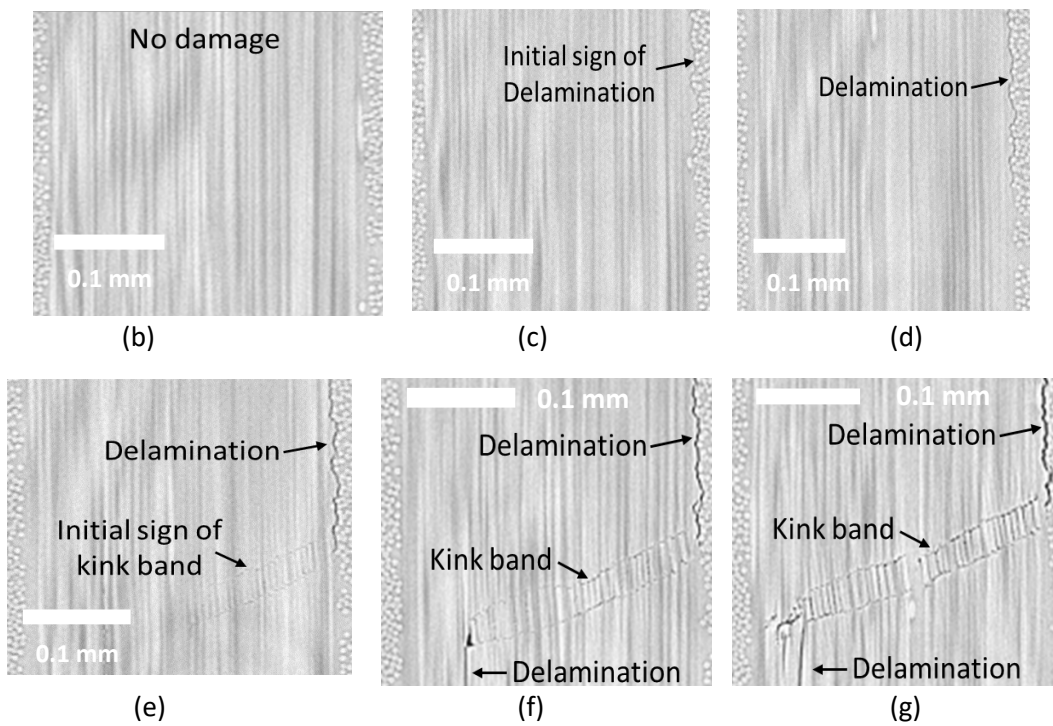
High magnification tomographs were obtained in the region of the kink band in the center zero-degree plies near the right notch tip as shown in Figure 15. In the specimen face-view tomograph of the center zero-degree plies shown in Figure 15a, it can be seen that the kink band initiated near the notch tip and grew toward the center of the test specimen. Very similar to the observations of notched cross-ply laminates in

Gutkin et al, 2010 [Section 4.1] [25], the kink band as shown in Figure 15a consists of multiple regions with varying angle and width. The root of the kink band is located off of the notch tip due to the shear concentration and subsequent splitting. From the root, a shear-driven fiber-compressive failure path forms at a nearly forty-five degree angle away from the notch and toward the center of the specimen. The kink band angle is shallower in the region where multiple fibers are rotated together. An intermediate kink band angle is due to fibers breaking in tension only on top of the rotated segments and an even more shallow angle exists further away from the notch where fibers break on two planes forming a kink band width of many fiber diameters. The location and direction of Figure 15 (b)-(g) is shown, with (b) being the farthest from the notch tip and (g) being the closest to the notch tip. It can be seen that location (b) is far enough from the notch tip that no damage is evident either in the form of a delamination or a kink band. Location (c) shows the first sign of a delamination that has formed between the center zero-degree and the ninety-degree ply. Figure (d) indicates that the delamination had grown and was fully established ahead of the kink band tip in Figure (e). At locations (f) and (g), which are closer to the notch tip, both the kink band and delamination were fully established.

Figure 15. High magnification μ CT tomographs of kink band in center zero-degree plies (a) face view (see Figure 13d; voxel size of $2.55 \mu\text{m}$), (b-g) through-thickness images progressing toward specimen notch (Voxel size of $0.395 \mu\text{m}$)

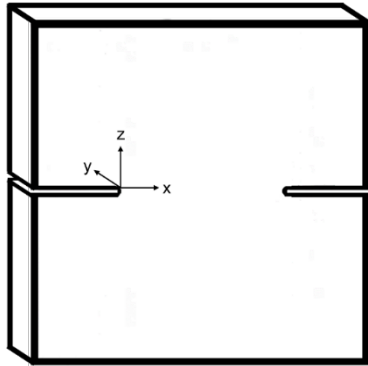
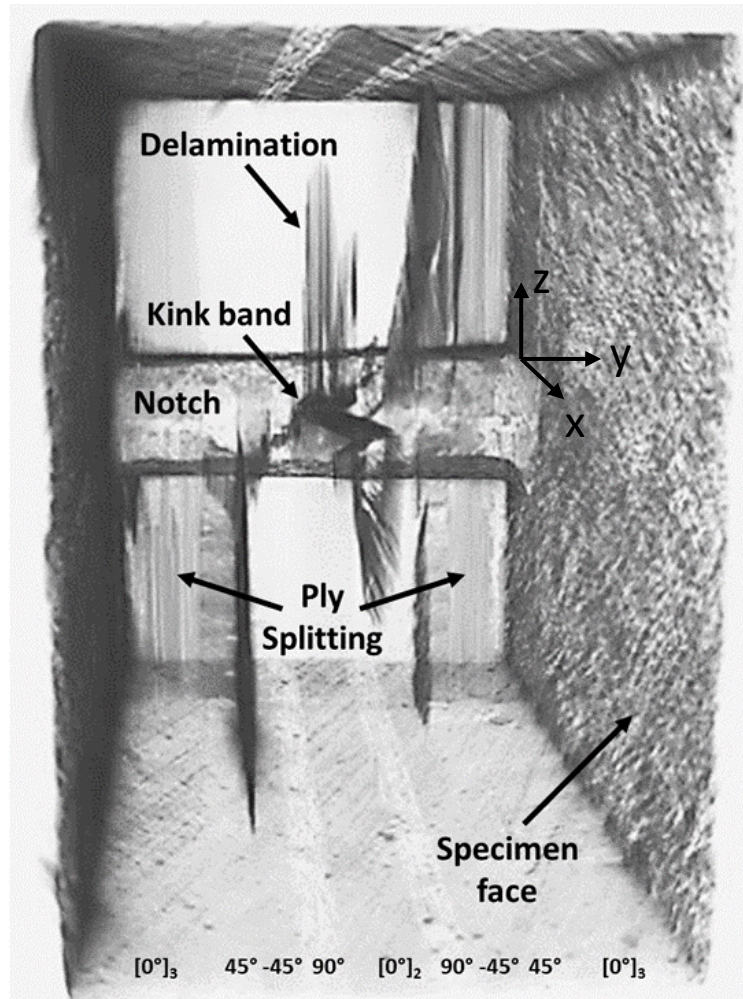
To better visualize the cracks and internal damage, an additional tomography scan was performed using a zinc iodide dye-penetrant solution containing ZnI₂ powder, water, isopropyl alcohol, and a wetting agent. Results from this scan are shown in Figure 16. Multiple forms of damage are present. First, a kink band is exhibited by a solid, opaque, crack-like feature that initiated at the notch in the central zero-degree plies and extended toward the center of the specimen. Multiple delaminations are shown as vertical fan-shaped features. These delaminations occurred on the +/- forty-five degree and zero/ninety-degree interfaces. The kink band is bound by delaminations at the interfaces between the zero-degree and ninety-degree plies.

Figure 16. Three-dimensional μ CT tomograph near notch of DENC specimen. The scan was performed using a dye-penetrant solution resulting in a voxel size of $7.55 \mu\text{m}$.
